THE LIFE CYCLE OF STRUCTURES IN EXPERIMENTAL ARCHAEOLOGY

AN OBJECT BIOGRAPHY APPROACH

edited by Linda Hurcombe and Penny Cunningham

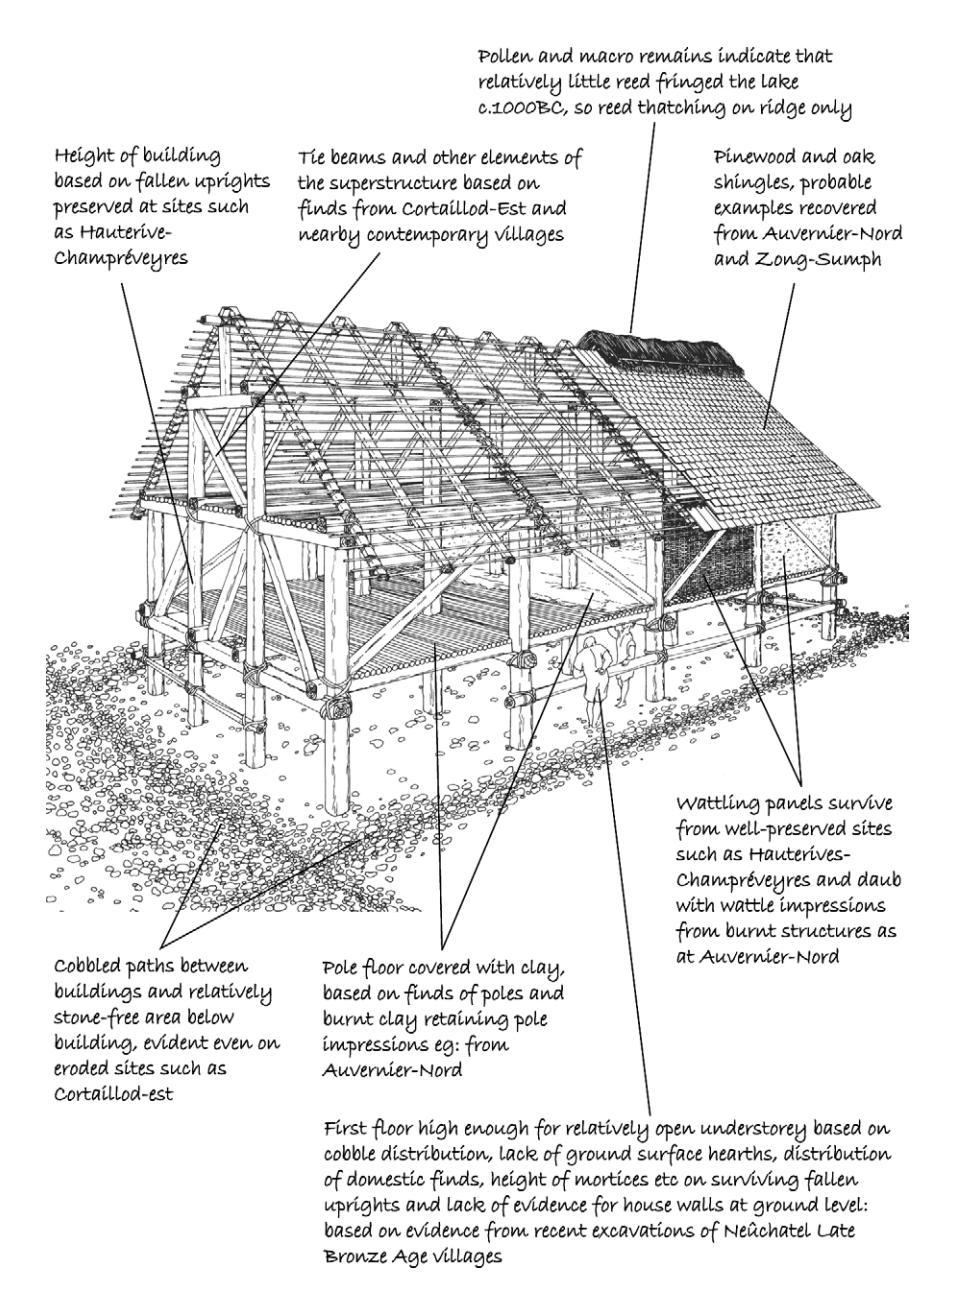
Figure 1.2: An example of how reasoned annotations might be useful features of reconstructed buildings based on a reconstruction drawing by Béat Arnold (1990, Fig. 69), after Coles (1992: 148, Fig. 16.1).

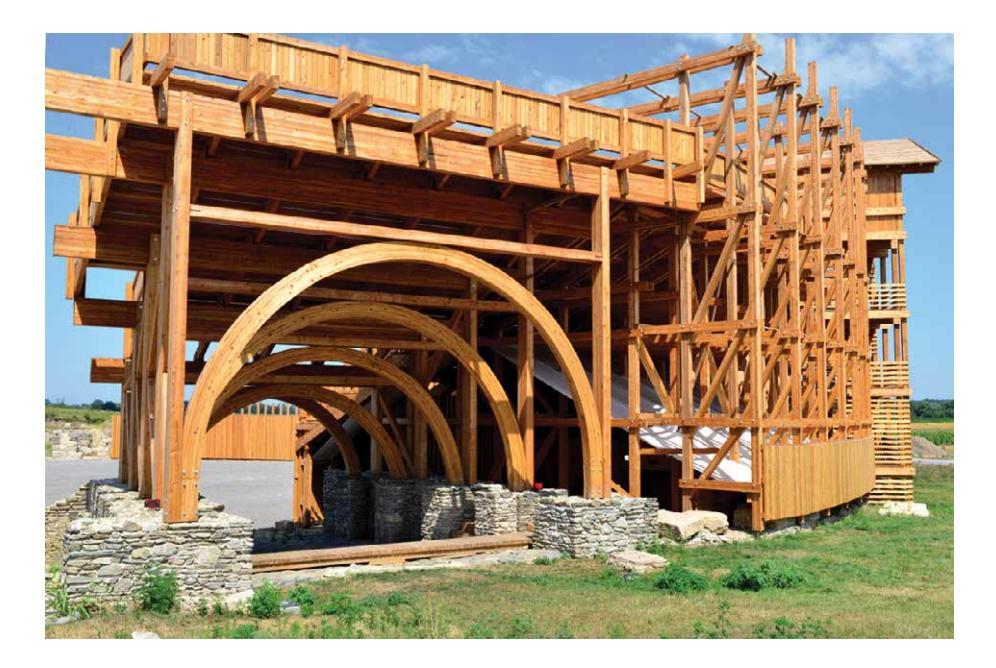
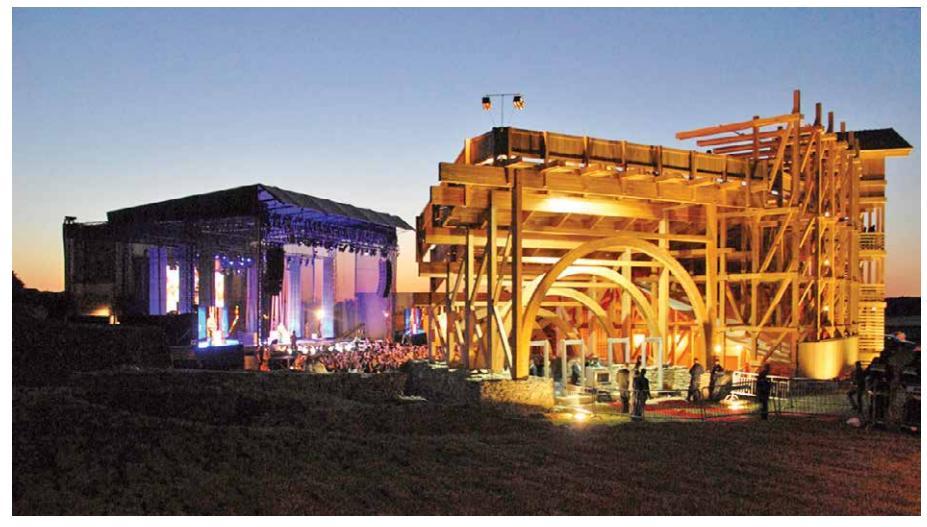
Figure 1.3: The wooden amphitheatre on modern stone foundations (top) and the amphitheatre in use during a production of Aida (bottom). Source: Viminacium.

a mixture of materials which changed over the three phases. It was decided instead to reconstruct it in wood as this was used in all phases for the auditorium and because a wooden building is not such a permanent structure as one of stone. If ideas about the reconstruction changed, the wooden building would be easier to replace or modify. The wooden structure still had to have modern foundations and the wooden construction used modern techniques although a future idea would be to have a section which showed the carpentry and finishing techniques and treatments that were relevant to the ancient way of building. In other words, the modern building would reflect better the ancient one, and also fit better with the ethos of modern reconstruction ethics (Figure 1.3). The idea was to make a building that could be used for modern spectacles and so some compromises were made. For example, the modern construction has wider, more comfortable seats but the Roman ways of creating the flow of people to allow a crowd to move away quickly at the end of a performance or in the event of fire was followed. These modern routes also had to conform to modern health and safety constraints (Figure 1.3).

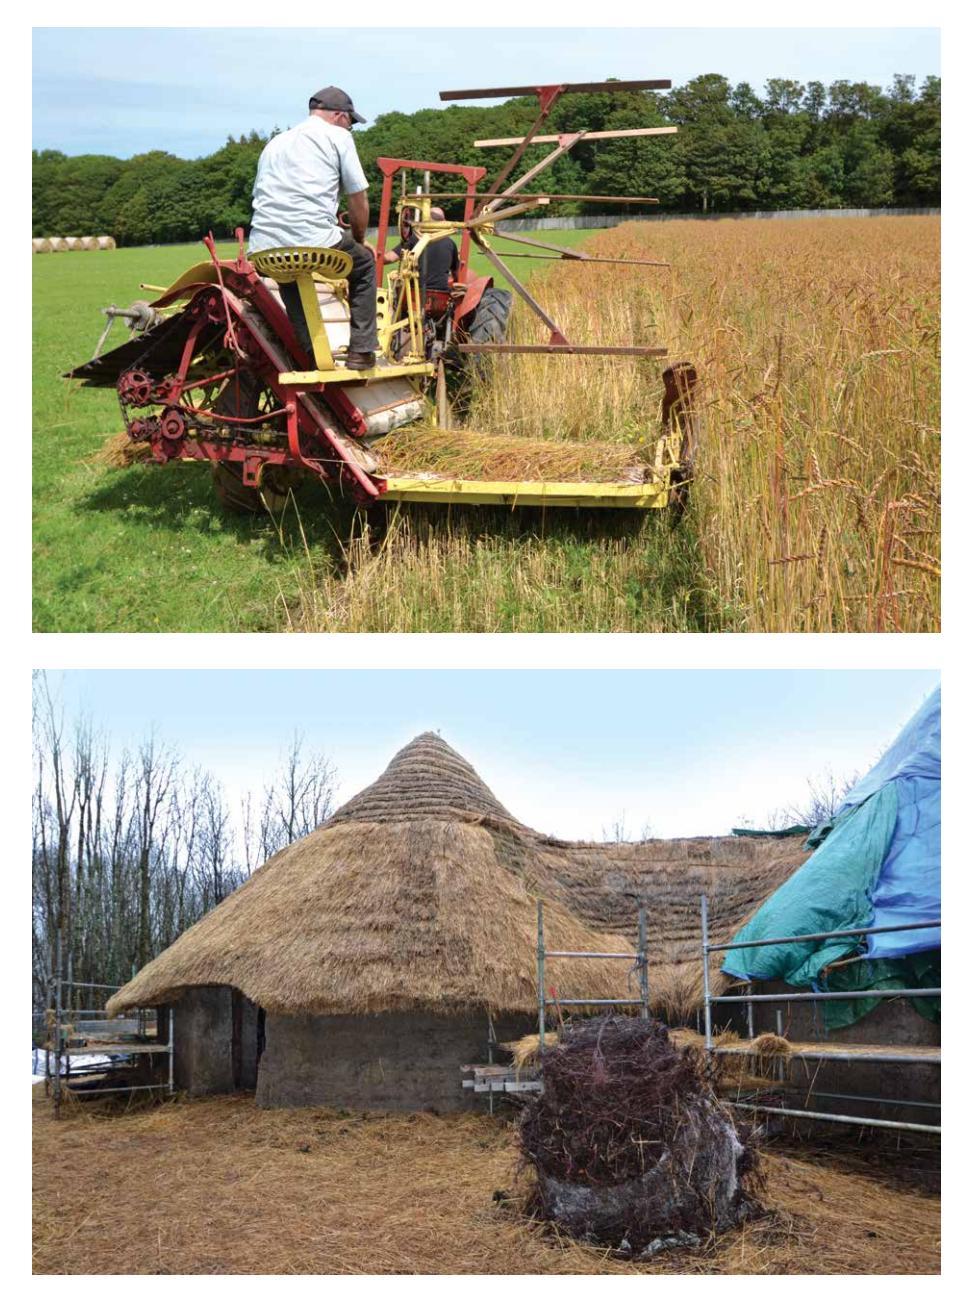
Figure 1.7: (Top) A reaper binder cutting spelt to be used as thatch. (bottom) Bryn Eryr partially thatched with spelt. Source: Steve Burrow.

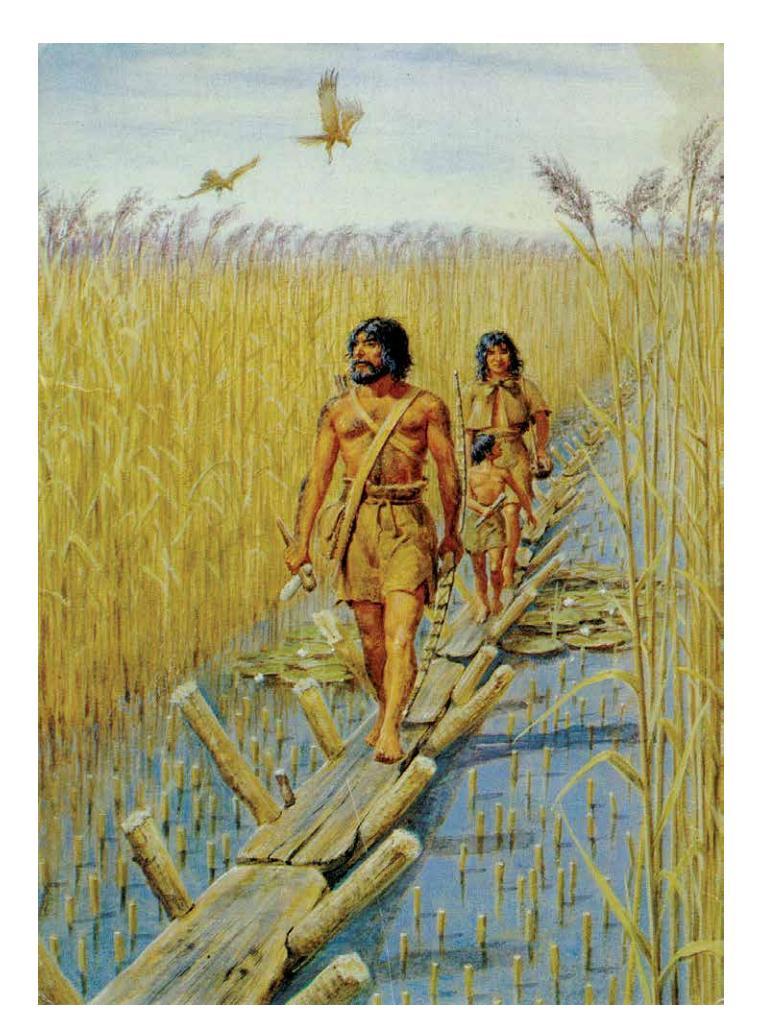
Figure 2.1: Reconstruction of the Sweet Track by E. Mortlemans.

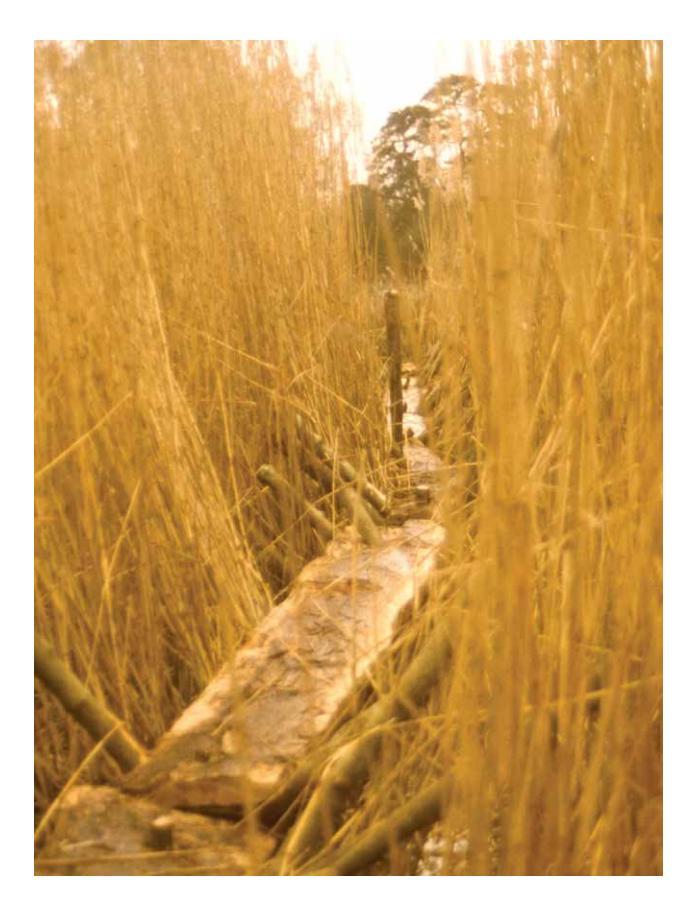
Figure 2.2: 1997 reconstruction of the Sweet Track in a reedbed in Shapwick Heath NNR. Source: Richard Brunning.

Although the 1997 trackway was not in constant use, the experiment permitted a reasonably reliable estimate of the lifespan of the structural components to be determined. The original raised walkway was supported by pairs of hazel roundwood stakes forming 'V' shaped cradles for the split planks of the walkway surface. After three years significant decay had taken place on the hazel stakes of the reconstruction at the interface between the air and water and after four years they began to break when the trackway was used. If the trackway had been in daily use, all the roundwood stakes would have required replacing after this period of time. Dendrochronological analysis has shown that planks were added to the original trackway in 3800 BC, six years after its creation (Hillam *et al.* 1990). This means that at least one replacement of roundwood posts was required during that period.

Suction prevented the removal of the broken roundwood posts on the reconstruction and this would probably also have been the case with the original, so all the stakes used in the life of the structure should have been visible during the excavations. Examination of the published plans (Coles *et al.* 1973; Coles and Orme 1976, 1979, 1984b) showed enough stakes to support the idea of one wholesale replacement, but not enough for two. This suggests that the trackway had an active life of seven to eight years as any longer period would have required a second replacement. The trackway built in 3806 BC therefore probably underwent wholesale repair in 3803 BC or 3802 BC, had some replacement planks added in 3800 BC and must have gone out of use by 3798 BC.

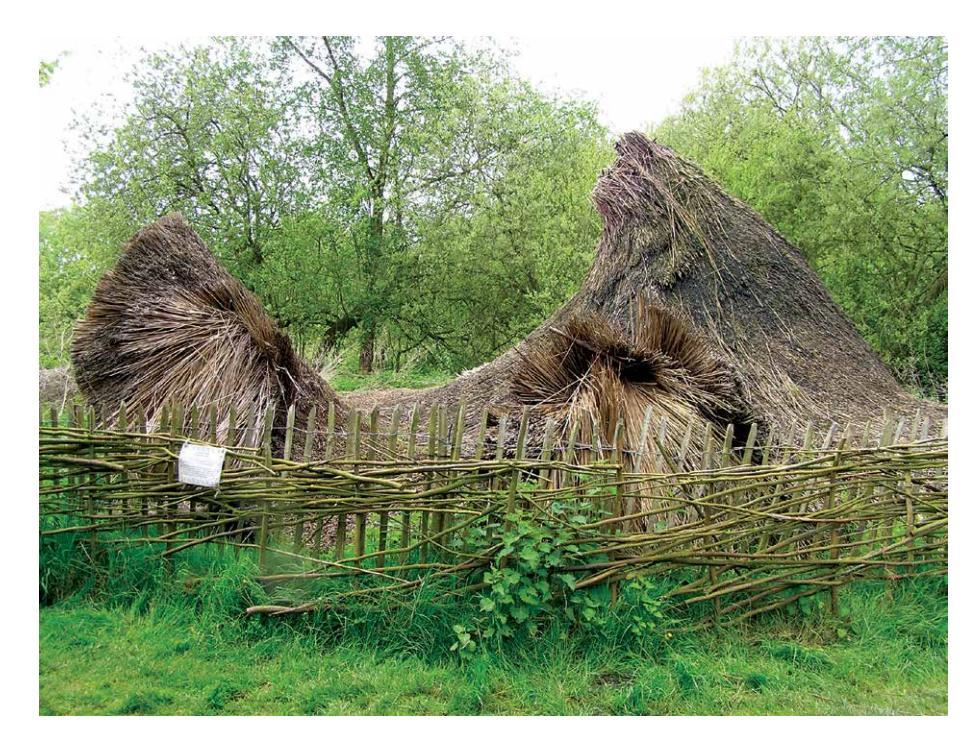
Figure 2.5: The original roundhouse at the Peat Moors Centre a year after its collapse began. Source: Richard Brunning.

The first two roundhouses have both been demolished after both staying up for two decades. This may give an impression of how long such structures could last but neither building was consistently lived in and both were left unheated during the closed winter season. This may have substantially reduced the longevity of the structures, as for example, a daily smoking would have helped to prevent the activity of woodworm and would have kept the thatch drier and more resistant to decay.

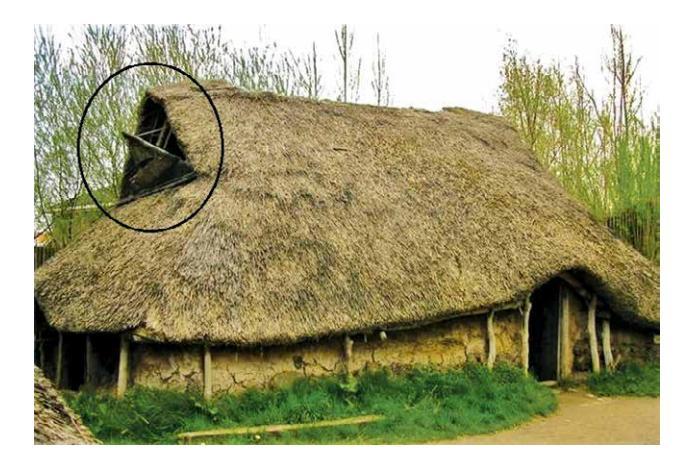
Figure 4.4: A gable end with an adjustable smoke flap made from skin in Archeon's Stone Age area. Source: Linda Hurcombe and Theresa Emmerich Kamper.

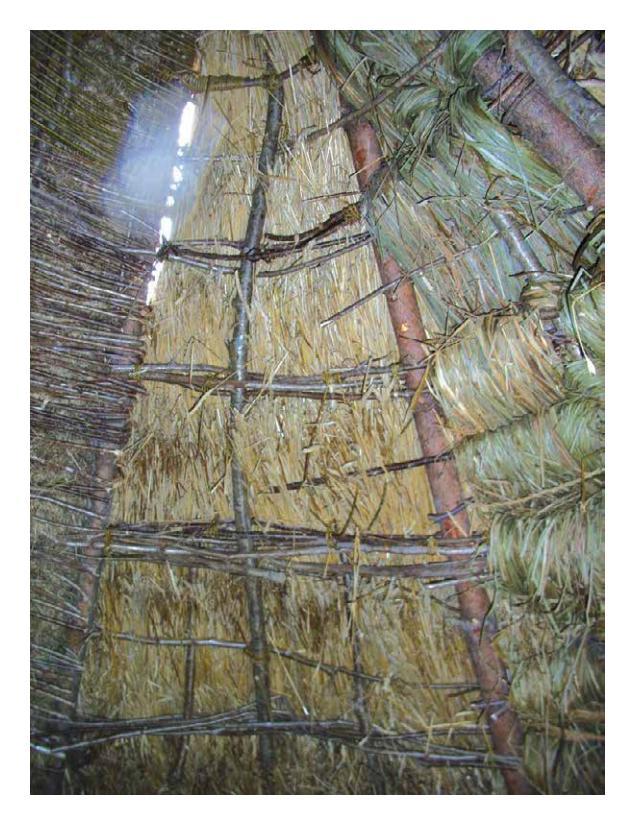
Figure 4.5: A section of roof from one of the ATC's temporary Neolithic hut structures where a mosaic of different materials were selected and tested. Source: Ancient Technology Centre.

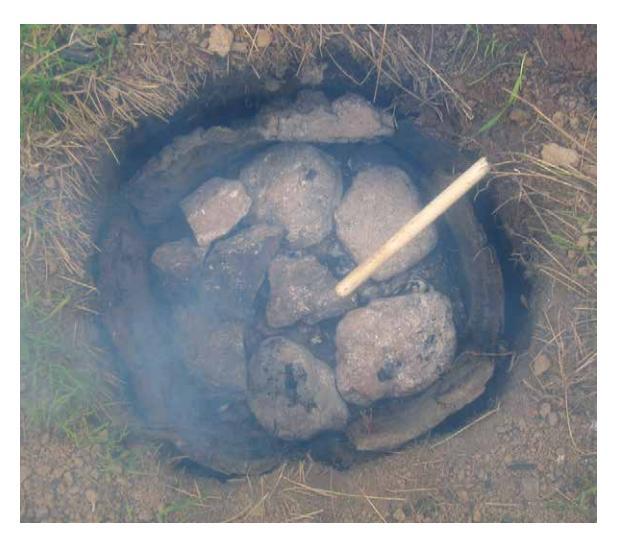
Figure 5.2: Roasting method 1: Hot rocks placed on top of hazelnuts (Photo: Penny Cunningham).

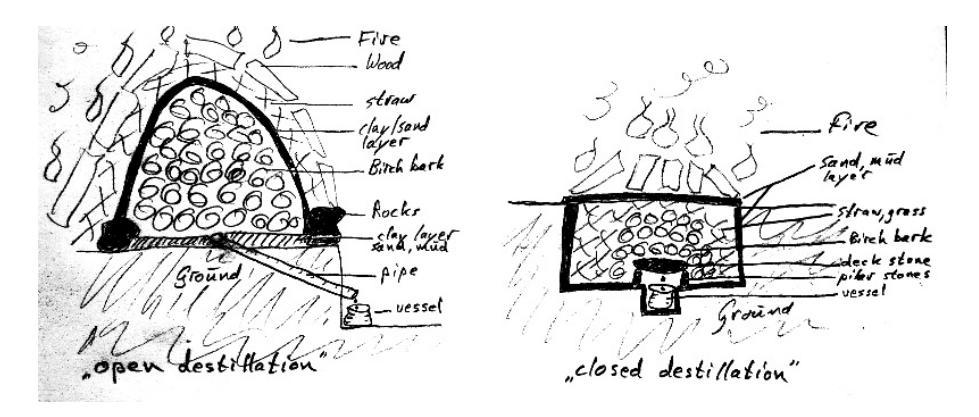
Figure 7.1: Diagrams to show the 'open' distillation and 'closed' distillation arrangements. Source: Werner Pfeifer and Marco Plaussen.

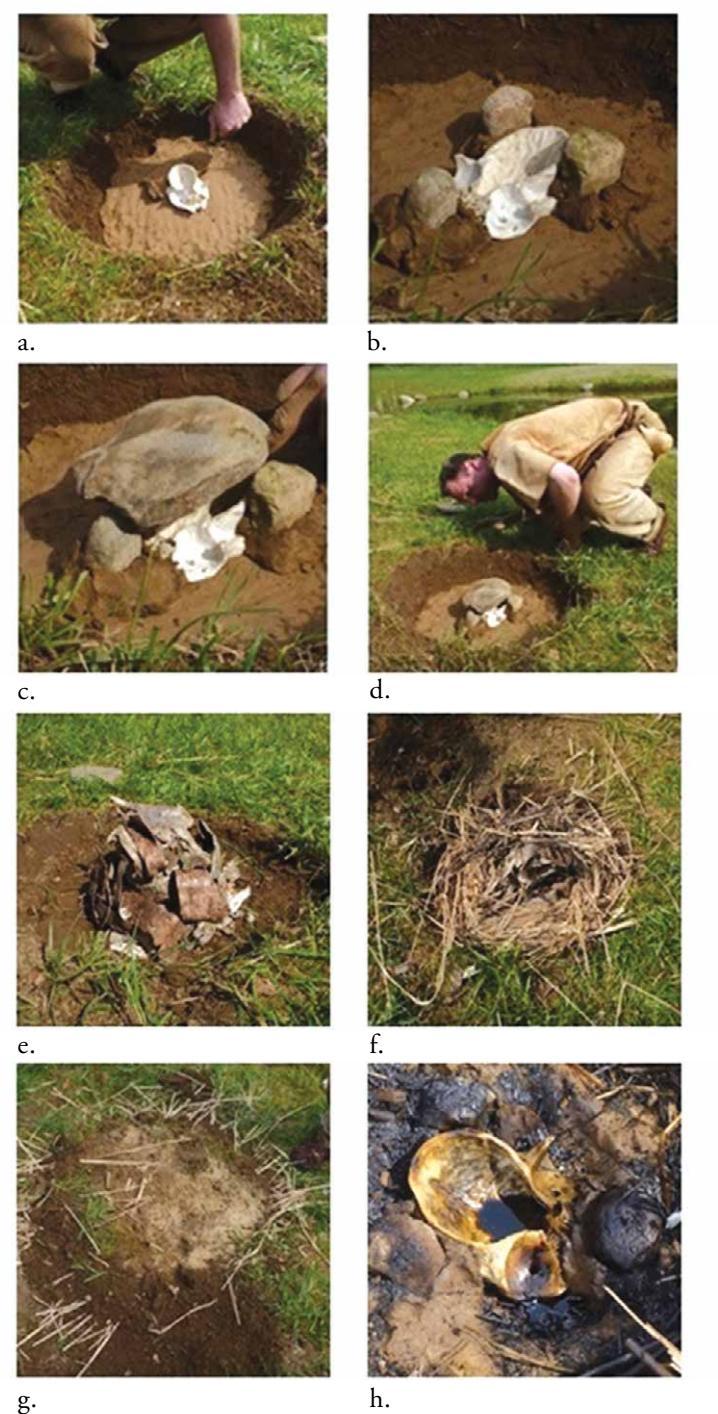
Figure 7.3: The 'closed distillation' method, with Marco. Source: Werner Pfeifer and Marco Plaussen.

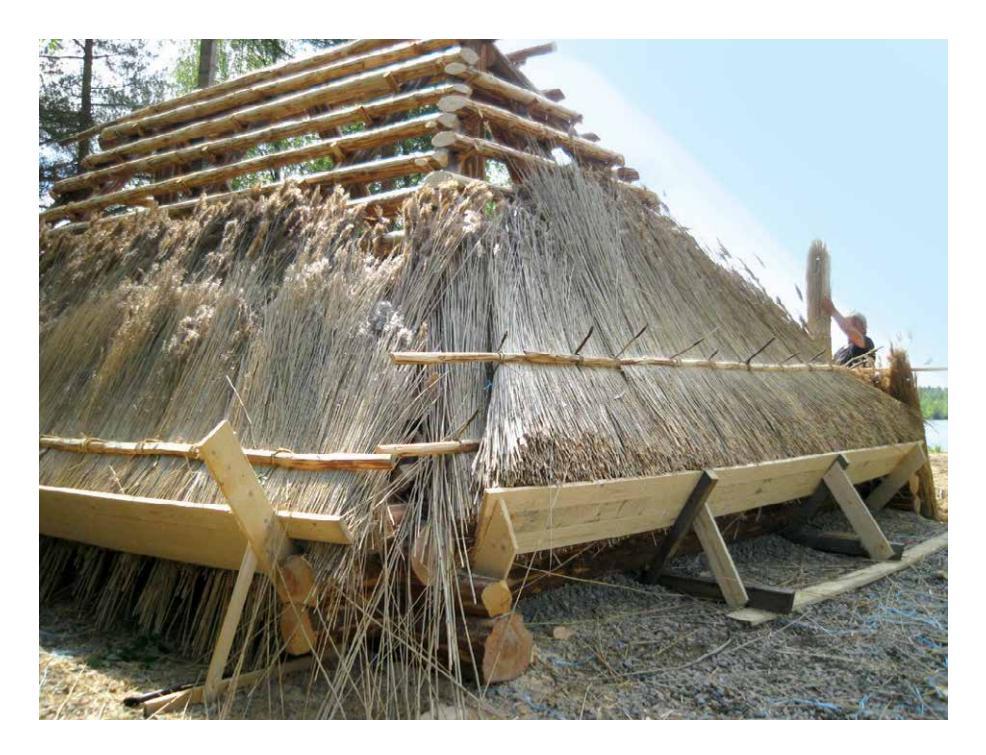
Figure 8.2: First layers of the reed were put on a scaffold and attached to the framing of the house with wood strips and twisted birch branches (Photo: I. Nieminen).

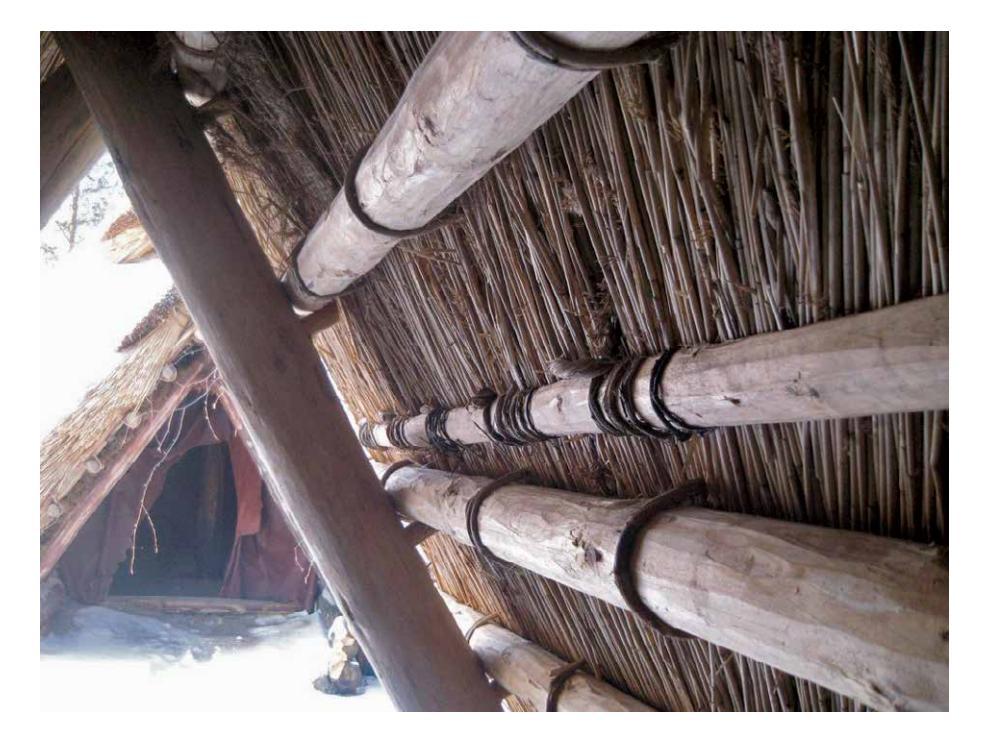
Figure 8.4: Walls from the inside. Twisted birch branches holding the wood strips on top of each layer of reed can be seen on the inside (Photo: I. Nieminen).

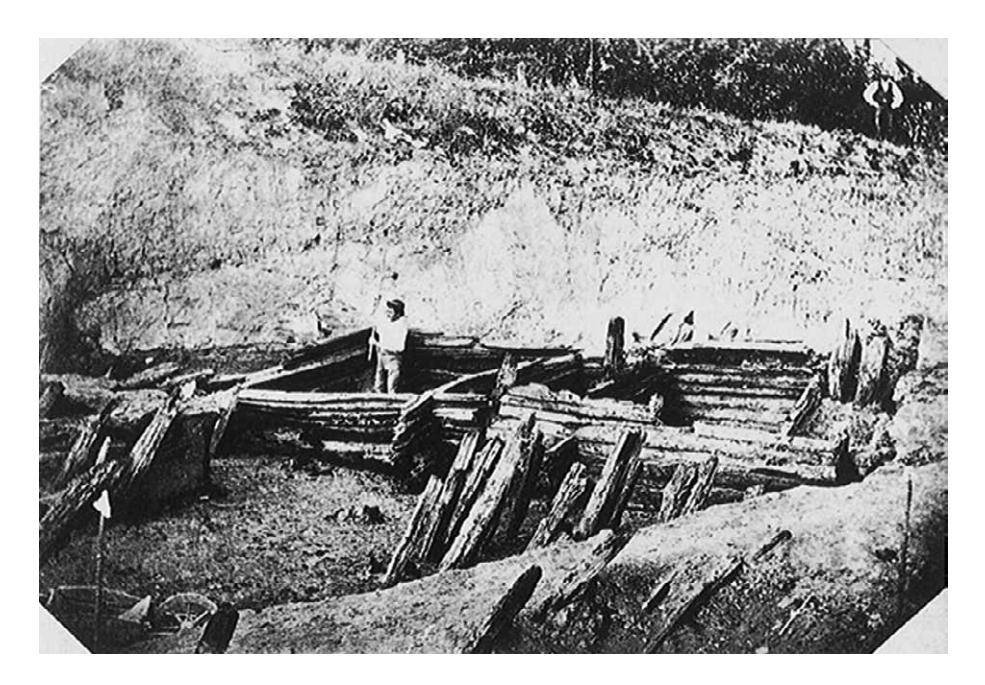
Figure 9.1: A photograph from the excavation at Terramara di Castione Marchesi from 1877 clearly shows wooden boxes placed together in a block design (Photo: L. Pigorini).
identify wooden log cabin boxes placed together in a block design (Figure 9.1), joined together in such a way that the protuberances of the boxes in turn formed their own compartments lengthways.

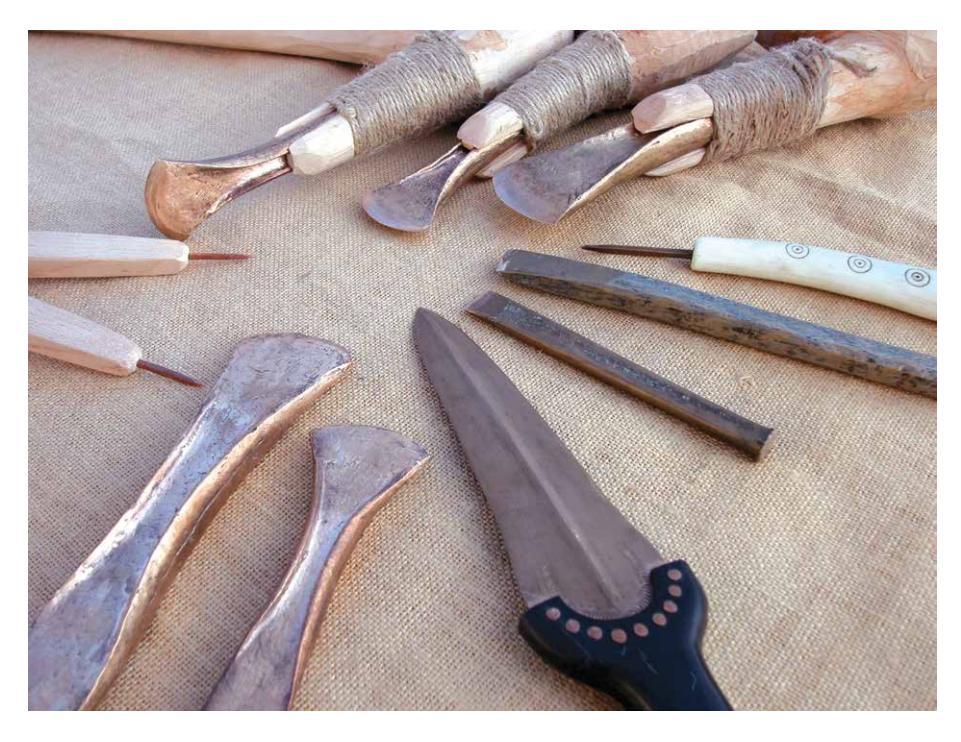
Figure 9.2: Some of the replicated tools we used made from bronze: flanged axes, adze, dividers, dagger, chisels and awl (Photo: W.F.A. Lobisser).

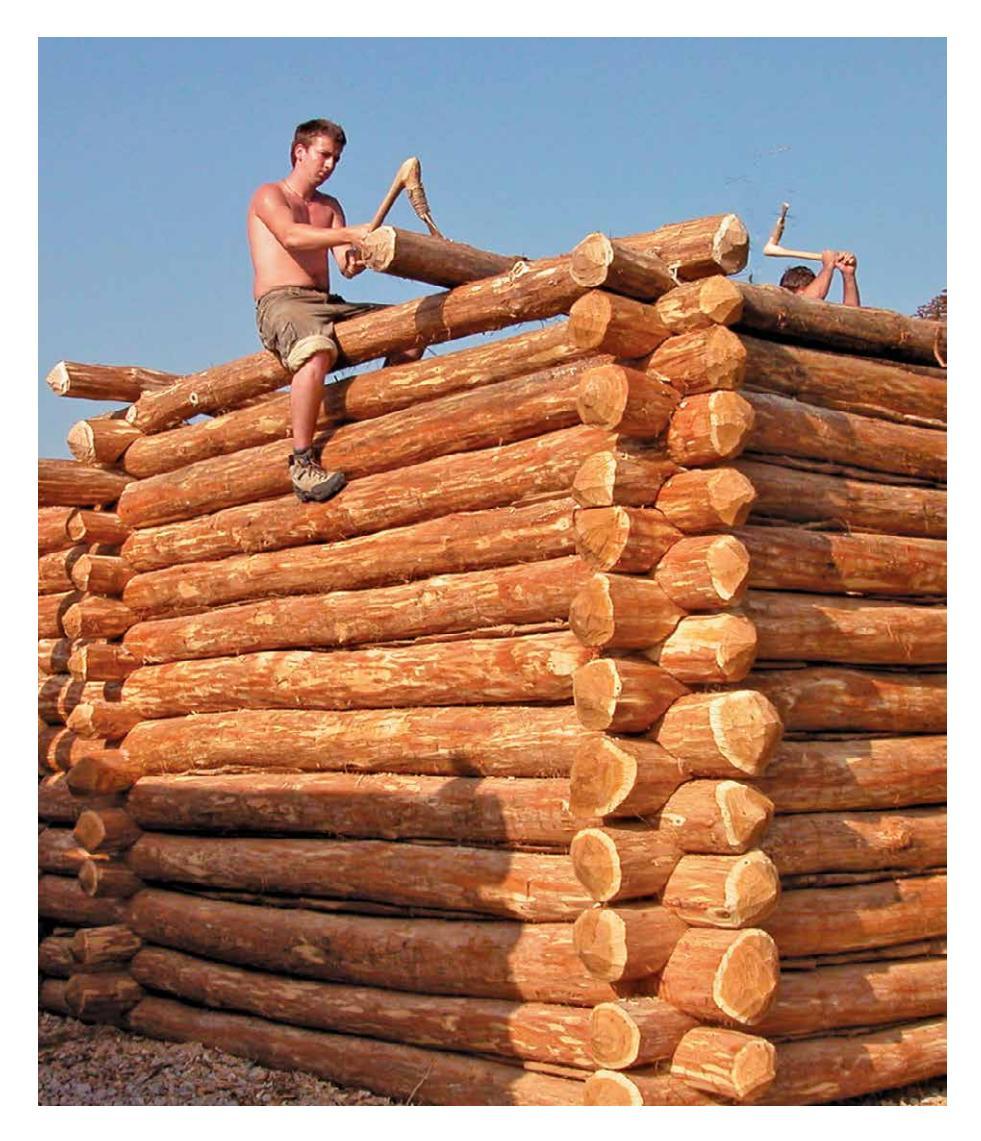
Figure 9.3: The heavy bronze axes were hafted onto naturally grown angular wood handles and proved to be useful tools for the construction of log cabin boxes (Photo: W.F.A. Lobisser).

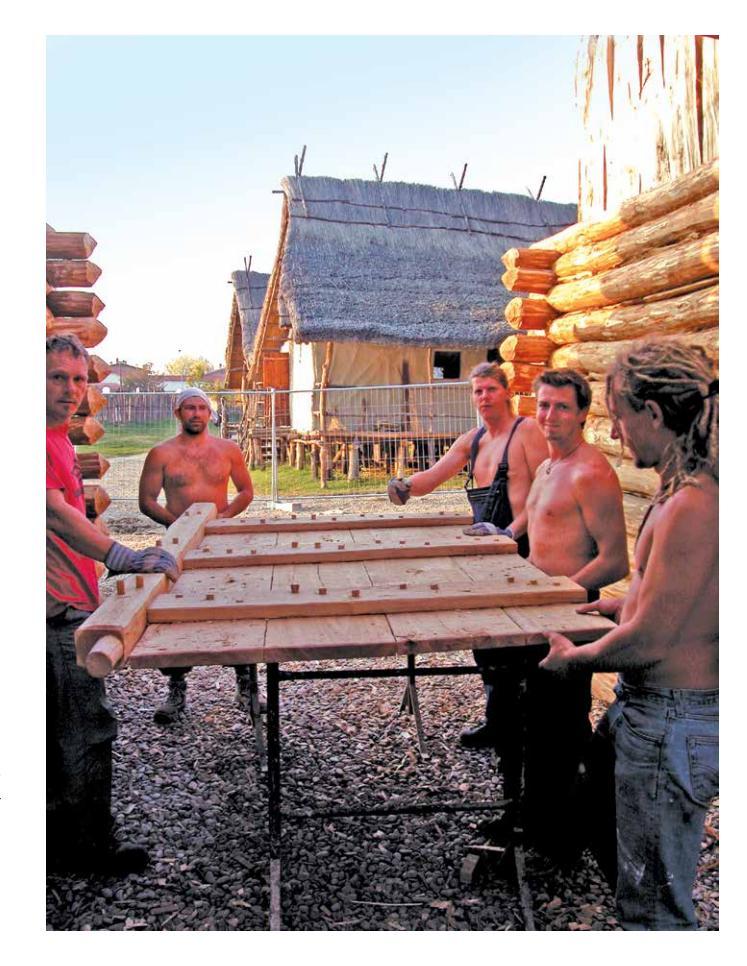
Figure 9.4: Five people were needed to position one of our gate leaves with an estimated weight of 150 kg and place it in the notches provided (Photo: W.F.A. Lobisser).

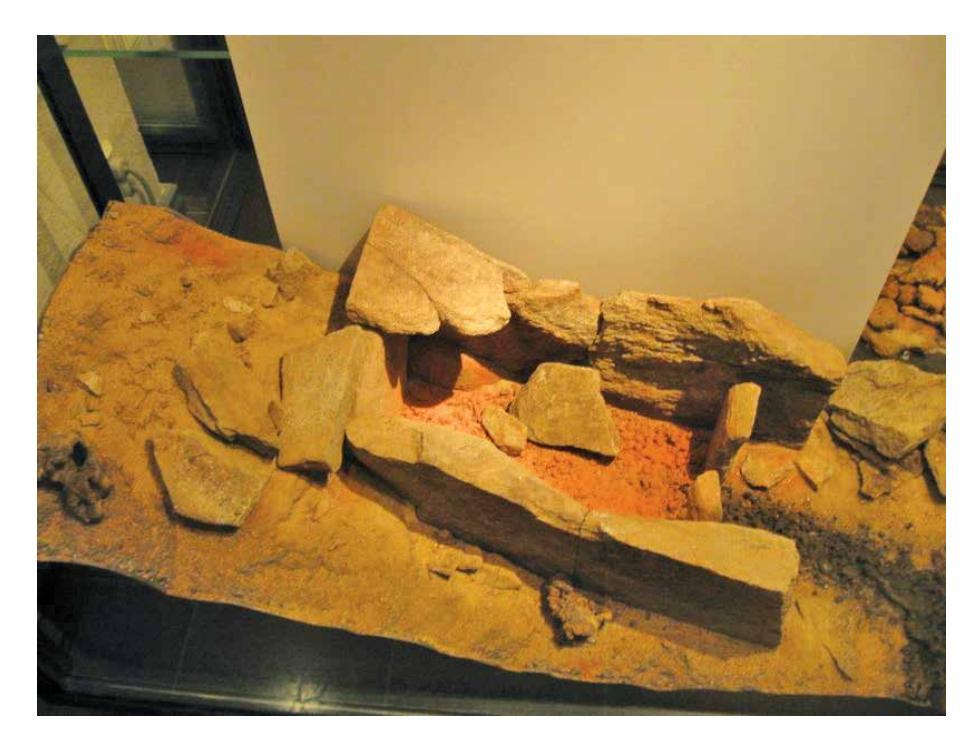
Figure 10.2: The furnace from Kotijänkä, Sierijärvi, Rovaniemi, as it is today in the National Museum of Finland reconstructed by Hannu Kotivuori (Photo: Joni Karjalainen).

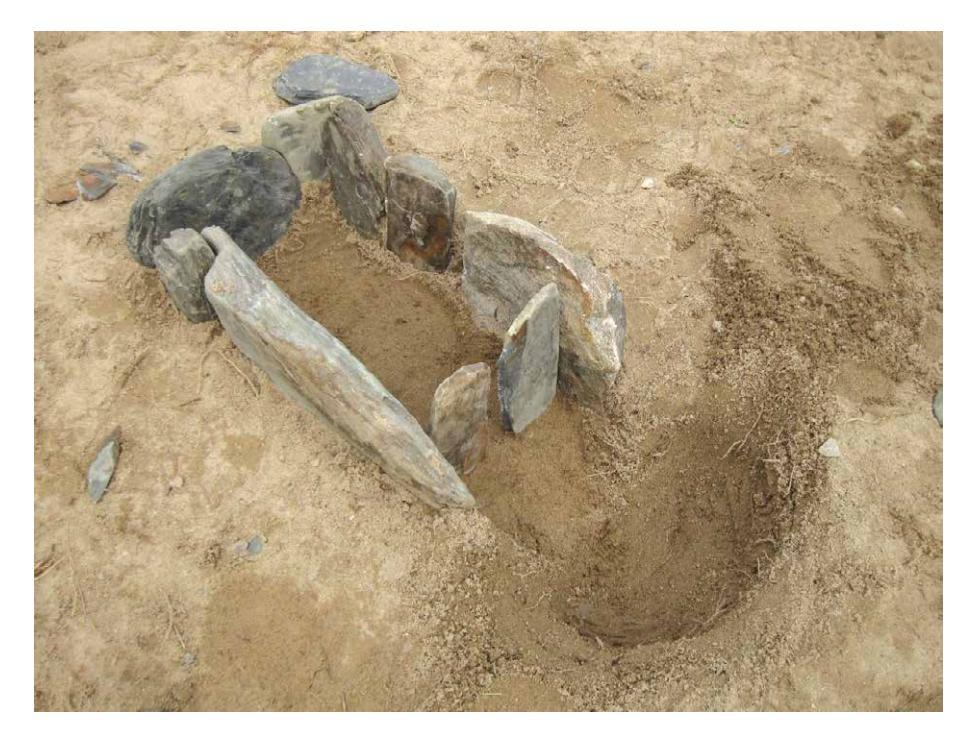
Figure 10.3: Our furnace with the stones and slag pit in place (Photo: Joni Karjalainen).

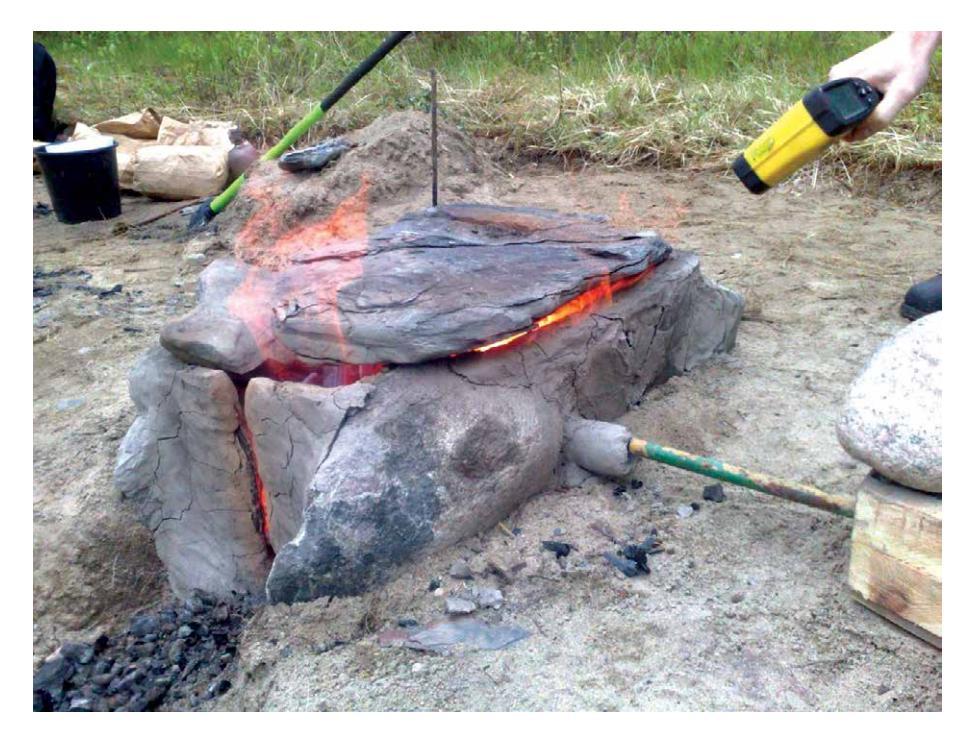
Figure 10.4: The furnace during the pre-experiment on Friday 13th in June. The cracks on the lid stone are already easy to see. An infrared thermometer documented 1417°C as the highest temperature reached inside the furnace (Photo: Juuso Vattulainen).

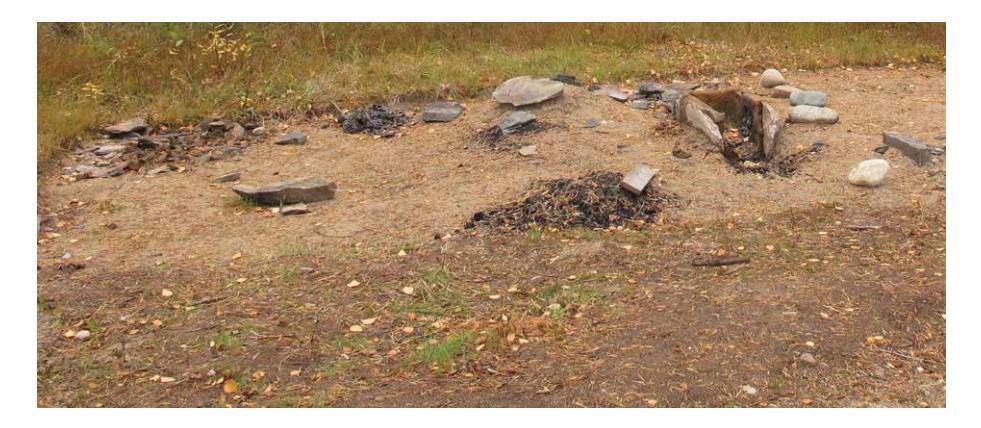
Figure 10.5: The smelting area after the three smelts. From left to right you can see the pile of stone and clay debris, small slag heap, parts of the last lid stones, small charcoal pile at the front and the furnace itself (Photo: Antti Palmroos).

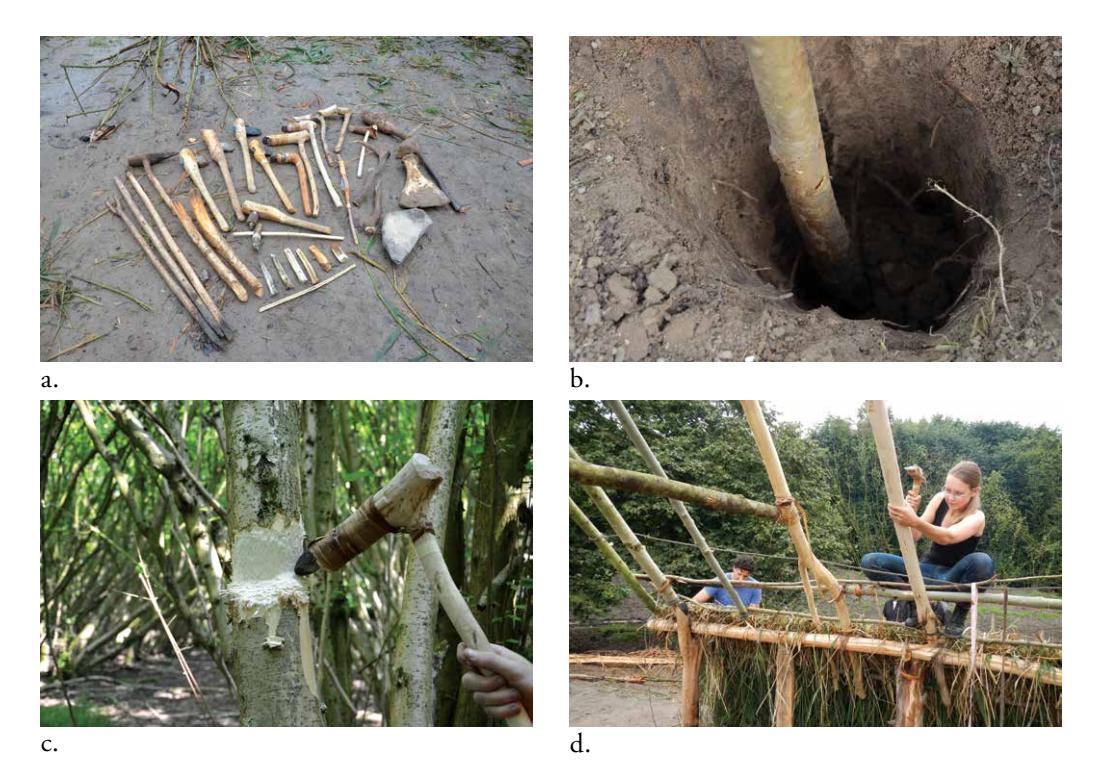
Figure 12.2: The tools in action. a) an overview of the tools used; b) a digging stick in action, note the perfectly straight posthole; c) chopping trees; d) placing the batten onto the rafters before the reeds were folded over them. Source: Annelou van Gijn and Diederik Pomstra.

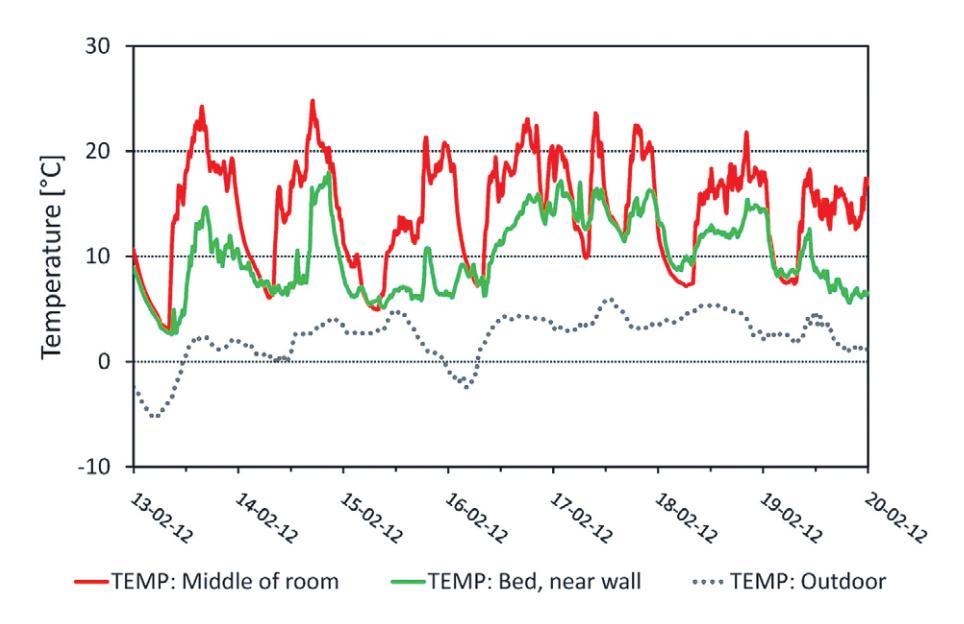
Graph 13.2: Temperature in House 2 during one week. Source: Jannie Marie Christensen.

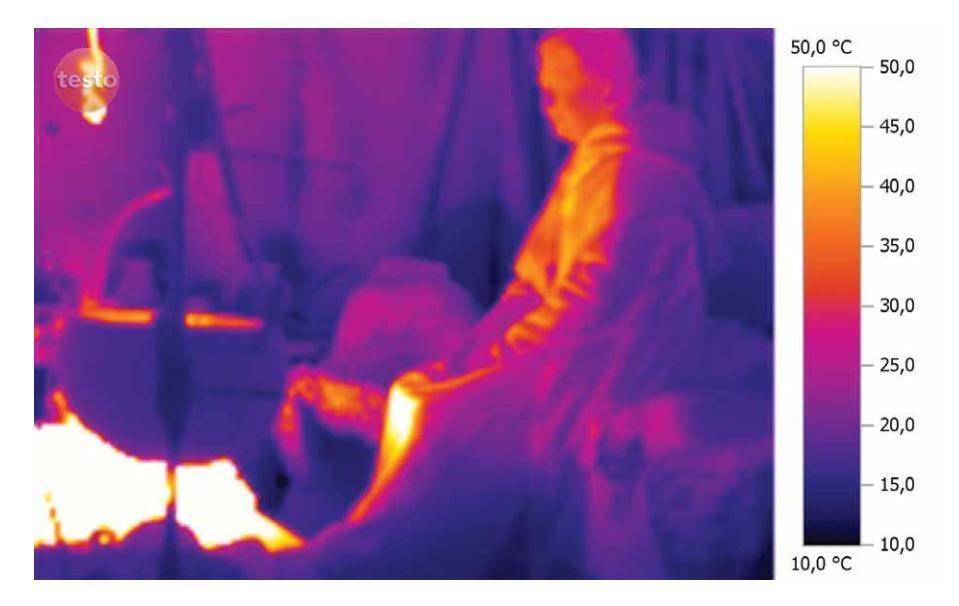
Figure 13.5: Thermal image showing the asymmetric surface temperature on a person's clothes (approximately 15-50 °C) and on the interior (down to 10-25 °C). Source: Jannie Marie Christensen.

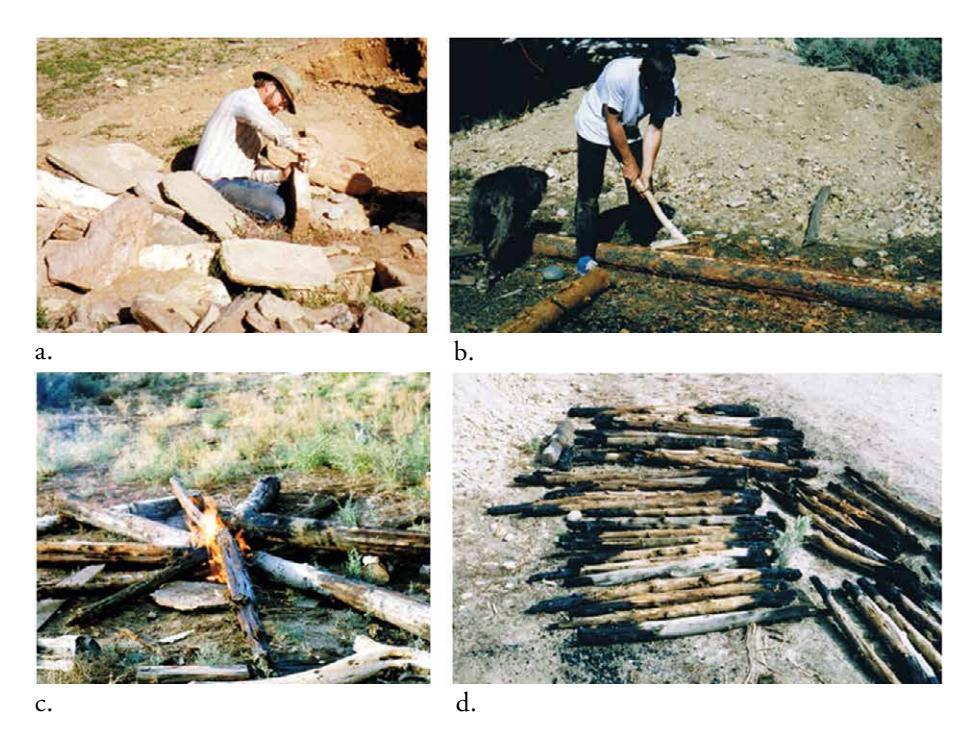
Figure 15.3: Building materials preparation: a) stone shaping: b) debarking pine beam; c) charring ends of juniper beams; d) juniper beams ready for use. Source: Bruce Bradley.

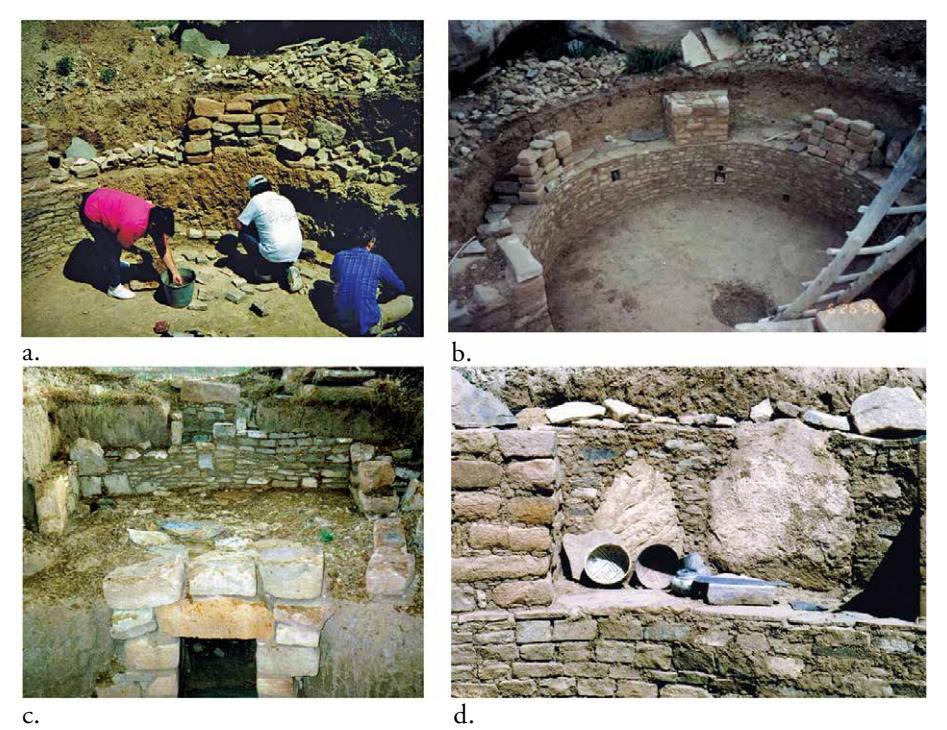
Figure 15.4: Masonry construction; a) lower lining wall; b) pilaster construction on banquette; c) floor-level vent tunnel and lining of southern recess; d) wall lining behind banquette segment. Source: Bruce Bradley.

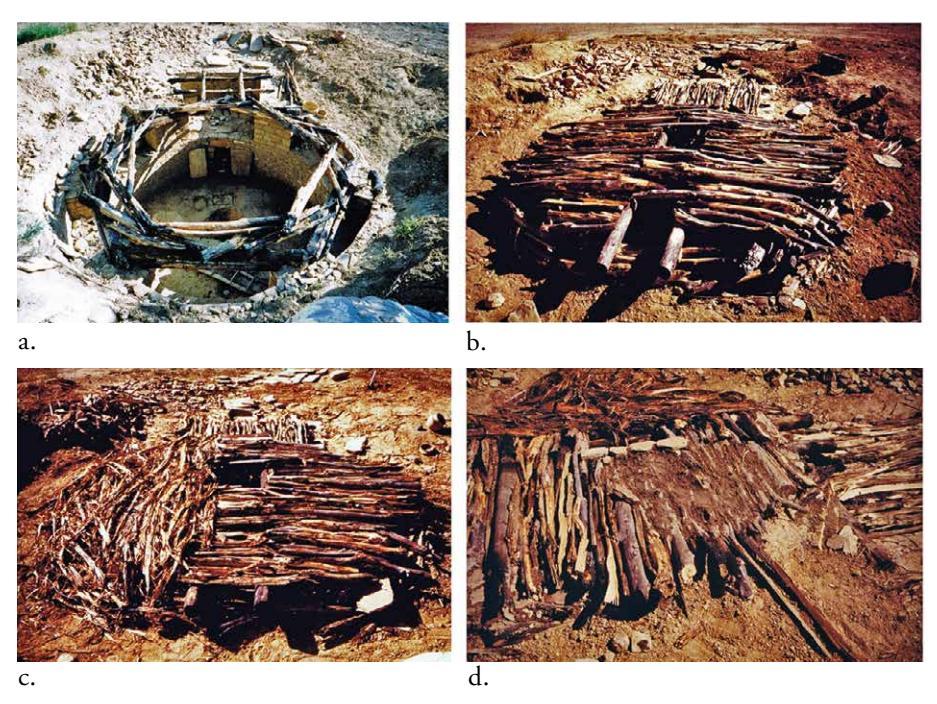
Figure 15.5: Roof construction: a) cribbed juniper beams; b) ends of central pine beams and layer of secondary beams; c) split juniper shake layer (on left); d) mud daub sealing spaces between secondary beams on banquette segment roof. Source: Bruce Bradley.

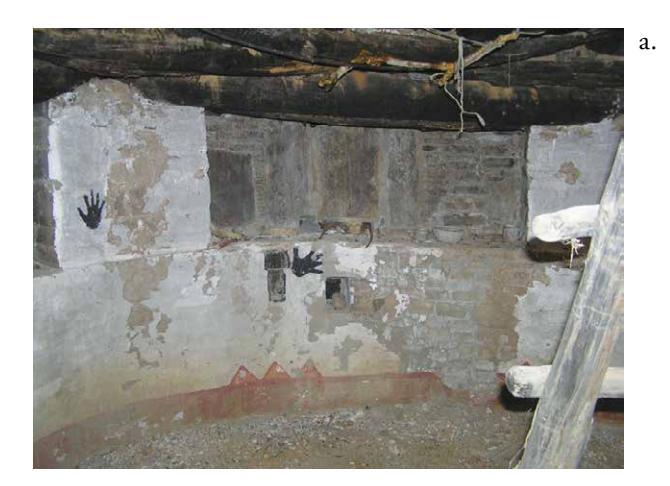
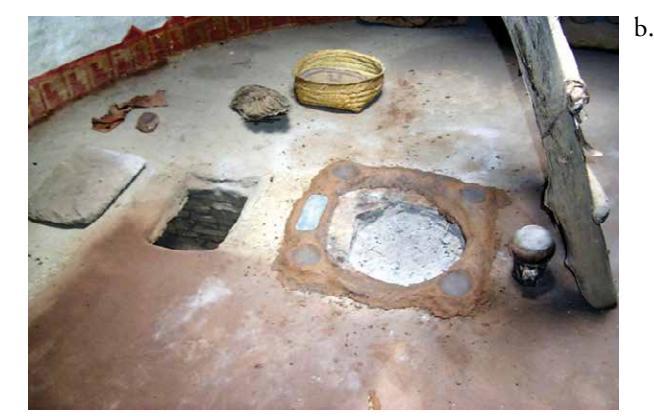
Figure 15.8: Maintenance: a) washed-out area before replastering and repainting in 1999; b) remodelled hearth in 1996. Source: Bruce Bradley.
