THE LIFE CYCLE OF STRUCTURES IN EXPERIMENTAL ARCHAEOLOGY

AN OBJECT BIOGRAPHY APPROACH

edited by Linda Hurcombe and Penny Cunningham

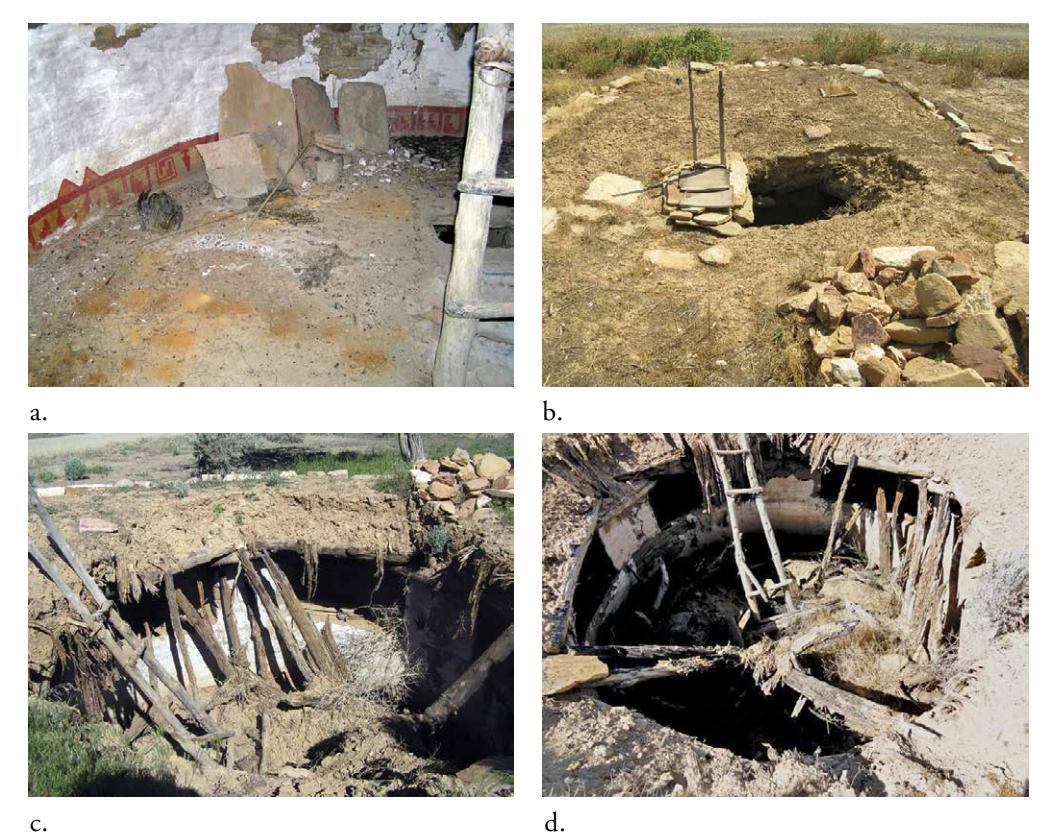
Figure 15.9: Structure collapse and weathering; a) main chamber floor in 2006 (note drip marks); b) collapse after main beam breakage in 2009; c) roof collapse in 2010; d) roof collapse in 2012. Source: Bruce Bradley.

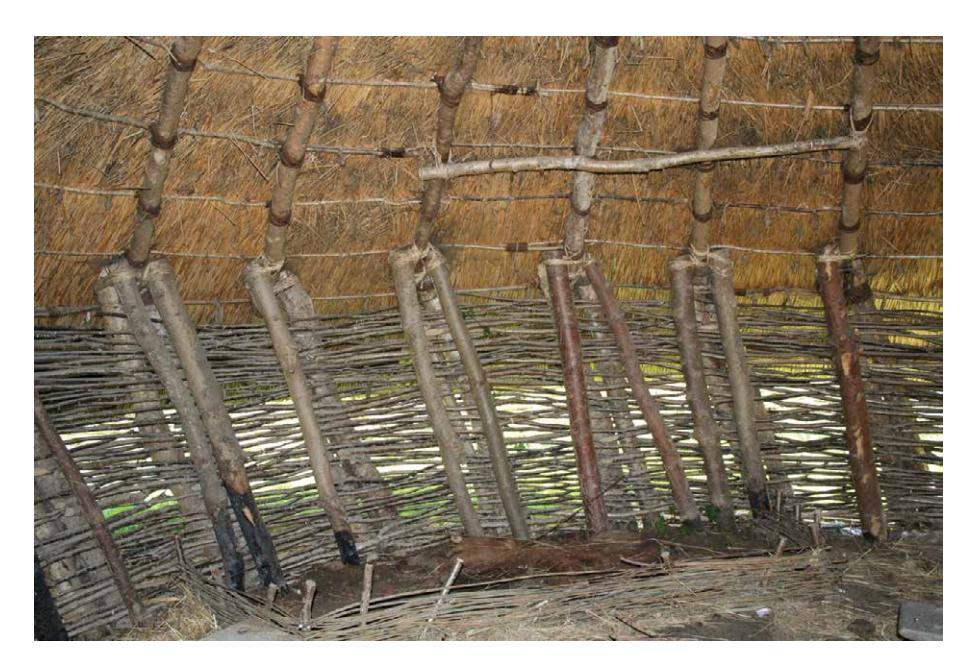
Figure 16.2: Buttress posts were inserted in 2003 in an effort to slow the decline of the Forge. Five years later, they too had been pulled out of their sockets: note the fire-blackened ends, which had previously been below ground level (Photo: Tríona Sørensen).
